BROWNS VALLEY DIKE
BROWNS VALLEY, MINNESOTA
Lake Traverse Project

HISTORY AND POTENTIAL FOR INTERBASIN FLOW

Kenton Spading, P.E.
U.S. Army Corps of Engineers
St. Paul District

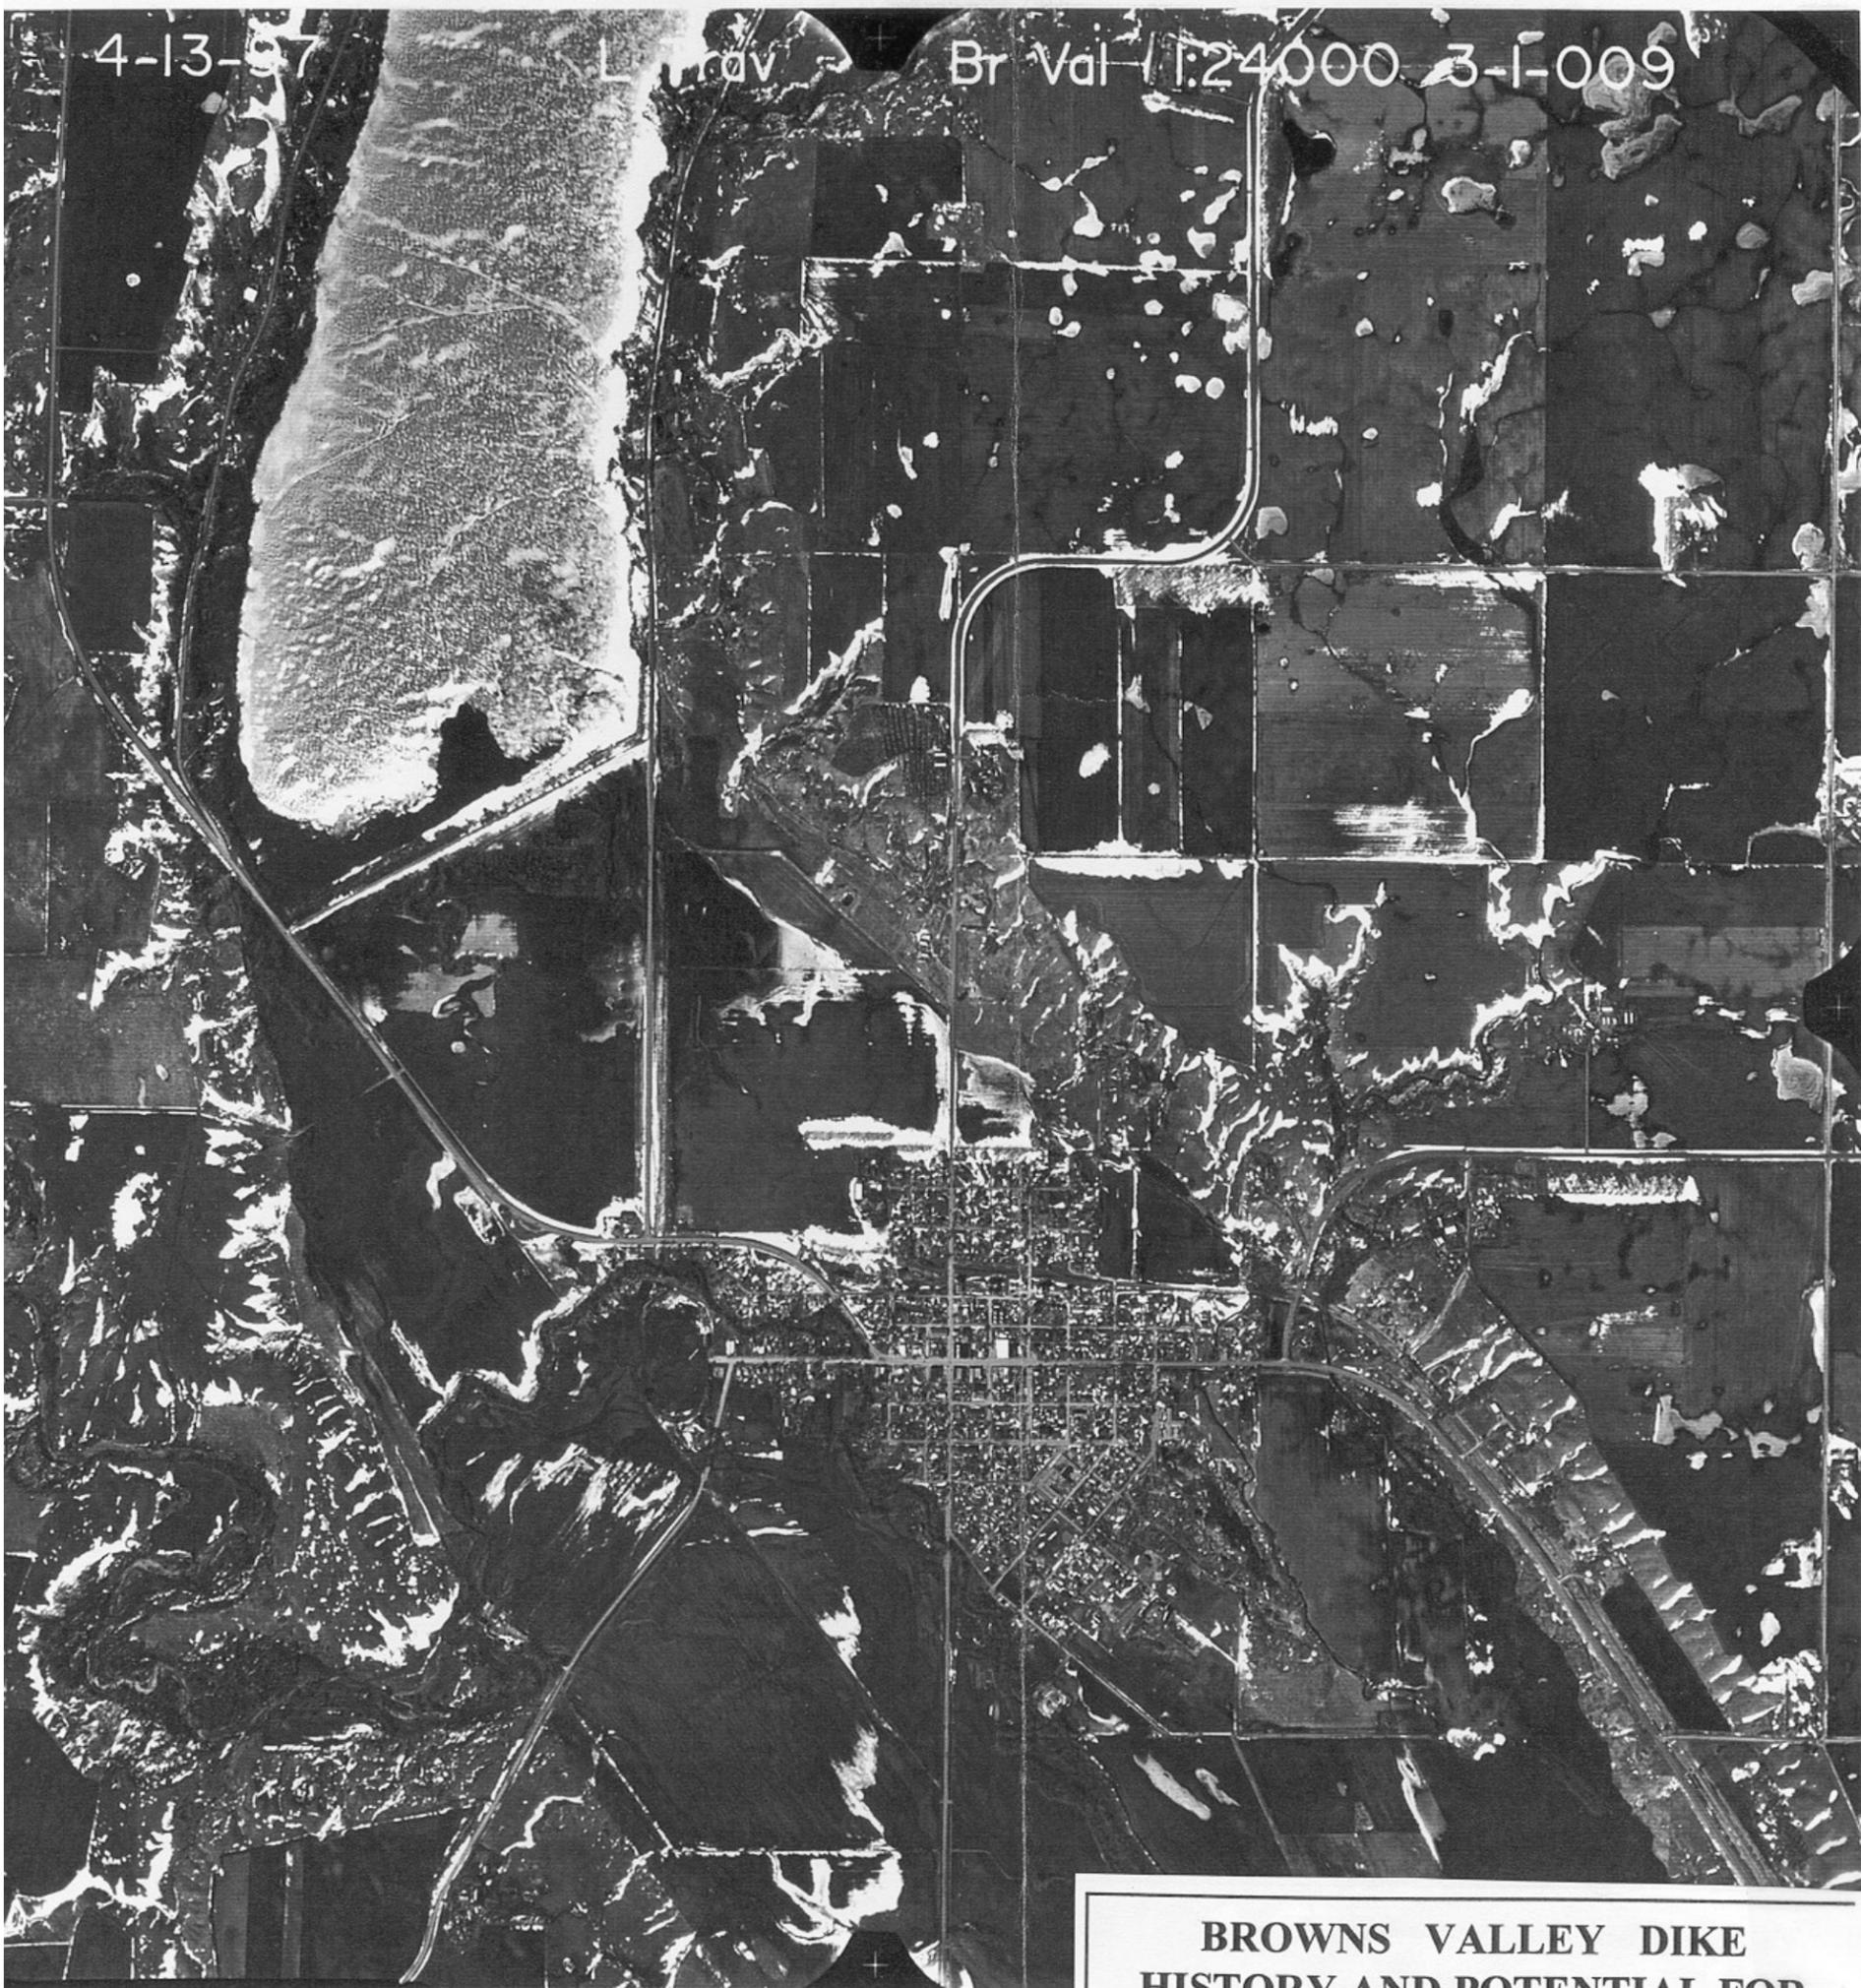
Plate 5-1

Aerial Photograph, Contact Print, April 13, 1997
Browns Valley, MN and Lake Traverse Reservoir

Two photos of the Browns Valley area taken during the 1997 flood are included with this report as **Plate Nos. 5-1 and 5-2**. **Plate 5-1** is an aerial photo taken on April 13, 1997 (**Reference No. 17**). The pool level of Lake Traverse on April 13 was 982.0 feet (the pool is ice covered).

The photos on **Plates 5-1 and 5-2** were taken at a time when the river was not of sufficient height to allow breakout flow over the left bank and hence into Lake Traverse (see **Paragraph 5.3.4.3**). However, the two photos appear to indicate that some water escapes from the right bank where it flows overland until it reenters the Little Minnesota River further downstream. The water appears to flow overland to Dakota Avenue (see **Plate 2-2**). It then crosses Dakota Avenue and

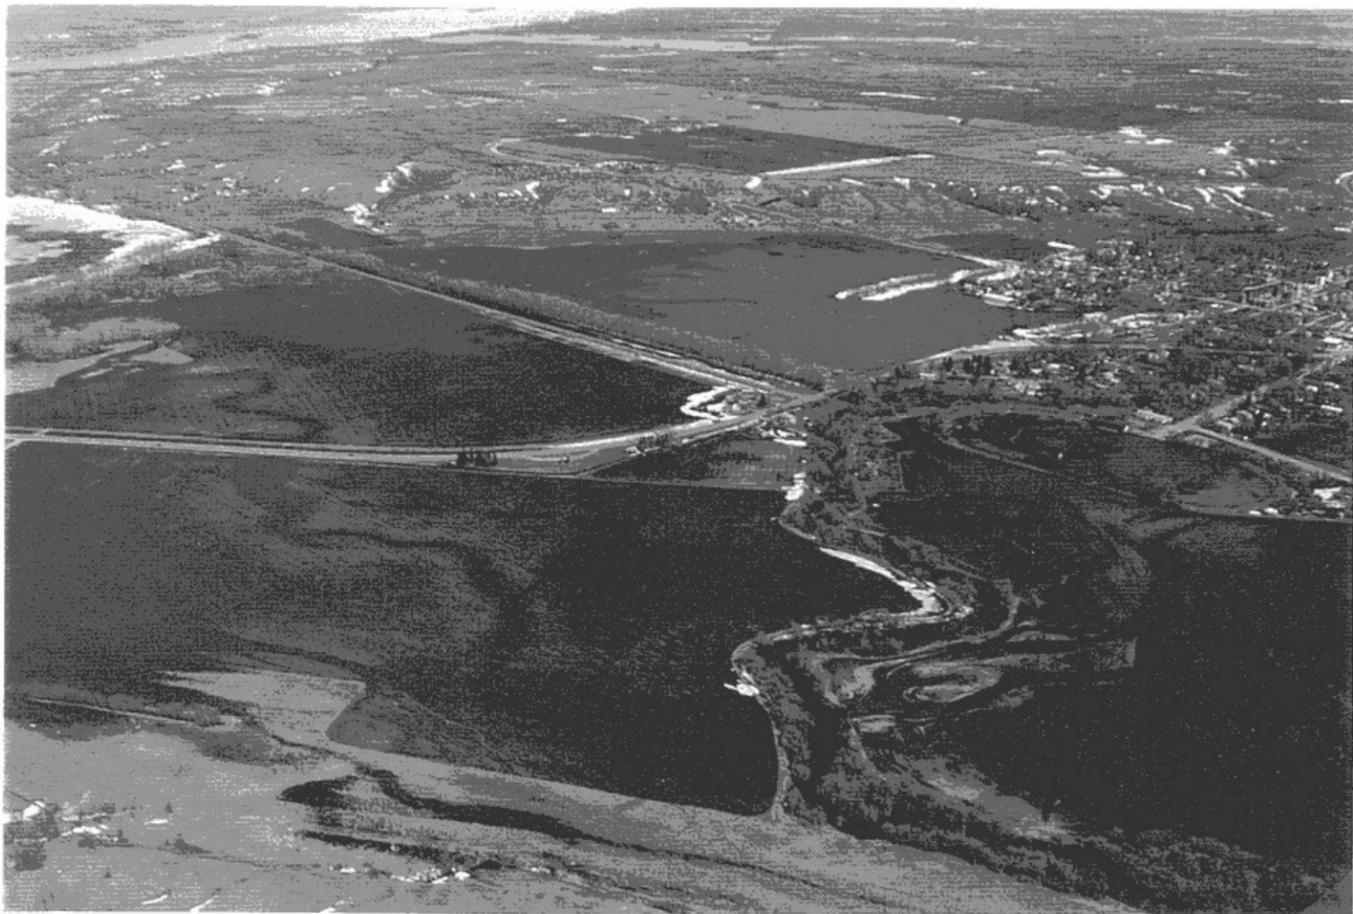
Aerial Photograph, Color Oblique, April 16, 1997
Browns Valley, MN and Lake Traverse Reservoir

Plate 1-2 can be used to reference the breakout area and the dike. Note that the small road south of the Browns Valley culverts is inundated. The mean daily flow in the Little Minnesota River on April 13 was 955 cfs (channel capacity is approx. 3,000 cfs, see **Paragraph 6.1.1**). **Plate 5-2** is a low-level color oblique photo taken on April 16, 1997 (**Reference No. 18**). The pool level of Lake Traverse on April 16 was 982.21 feet which is the highest pool level in recorded history (the pool is still ice covered). The breakout area is in the lower center foreground. The southern edge of the Lake Traverse pool can be seen in the upper left hand corner. The mean daily flow in the Little Minnesota River on April 16 was 1,210 cfs.
